THE GREAT ESCAPE – NEVER AGAIN?

On January 22, 2016, three inmates escaped from the Orange County Central Men's Jail (CMJ). The Grand Jury investigated the escape to determine how it occurred and to evaluate what steps have been taken, and still need to be taken, to ensure there are no future escapes.

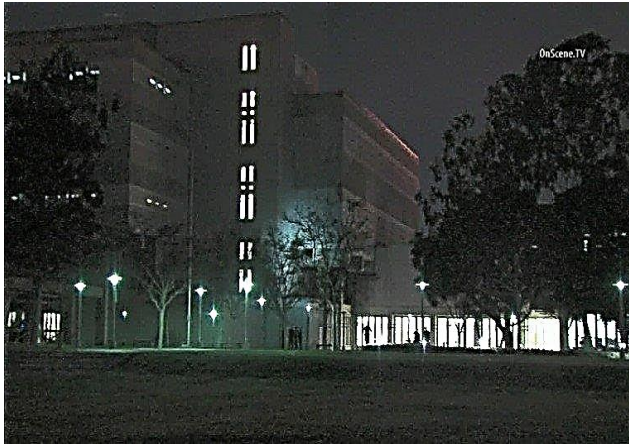
Figure 1 (Before)

Jail Perimeter Lighting: Before and After the January 2016 Escape

After the escape, it was discovered that some CMJ personnel failed to comply with various sections of the OCSJ policy and procedures manual. One such policy requires a physical check of the plumbing tunnels once per shift. The purpose of this inspection is to locate signs of tampering, identify any unsafe conditions, and observe inmates. Findings are to be documented on the applicable station log. In spite of clear policy, plumbing tunnels were not regularly checked by some deputies prior to the escape. Although maintenance workers went into the plumbing tunnels, it was only for repair and maintenance of plumbing and electrical issues and they were not responsible for inspecting the tunnels for signs of criminal activity. Since the escape, deputies now follow procedure and check plumbing tunnels for signs of illicit activity at least once per shift. In addition, plumbing tunnels have been thoroughly cleaned, existing light bulbs have been replaced with brighter bulbs, and additional lighting and motion detectors have been installed.

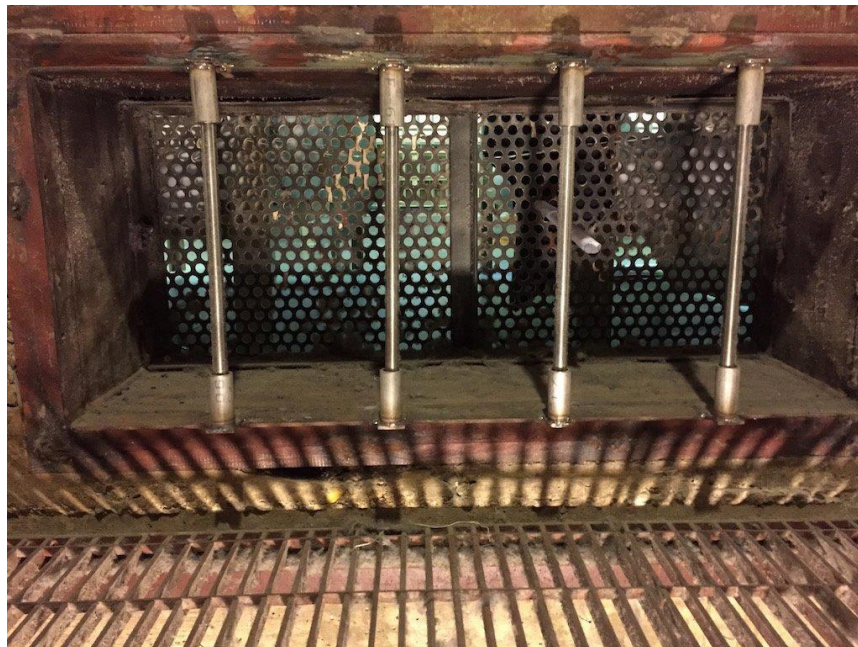
Figure 3

- CCTV in the plumbing tunnels
- Motion sensors
- Radio frequency identification (RFID) tags for all inmates
- Vent bars (see Figure 3)
- Security mesh bars

Vent Bar Reinforcement: After the January 2016 Escape

Additional components of the hardening process, recommended by an OCSJ Jail Hardening Team formed shortly after the jail escape, include the addition of metal grills to plumbing tunnel wall vents; addition of secondary grills to existing security grates; and an upgrade to high density LED lighting on the roof and perimeter of the building (see Figures 1 and 2). Part of the long term hardening desired by the OCSJ is to fence the roof completely. If that proves to be too costly, fencing will be added around air handler/roof vent units, which were used by the inmates to access the roof and escape.
