THE GREAT ESCAPE – NEVER AGAIN?

The Great Escape - Never Again?

SUMMARY

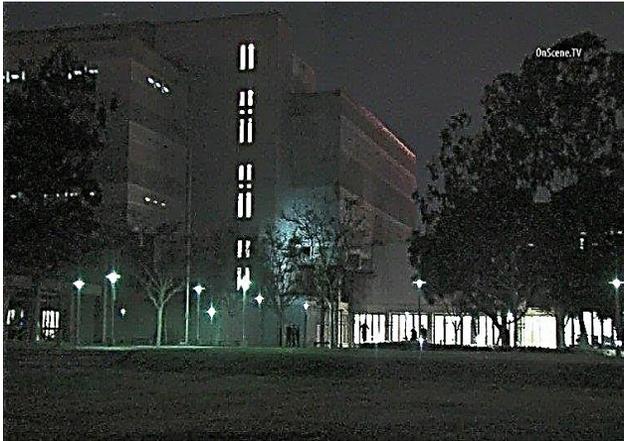
Figure 1 (Before)

Jail Perimeter Lighting: Before and After the January 2016 Escape

After the escape, it was discovered that some CMJ personnel failed to comply with various sections of the OCSJ policy and procedures manual. One such policy requires a physical check of the plumbing tunnels once per shift. The purpose of this inspection is to locate signs of tampering, identify any unsafe conditions, and observe inmates. Findings are to be documented on the applicable station log. In spite of clear policy, plumbing tunnels were not regularly checked by some deputies prior to the escape. Although maintenance workers went into the plumbing tunnels, it was only for repair and maintenance of plumbing and electrical issues and they were not responsible for inspecting the tunnels for signs of criminal activity. Since the escape, deputies now follow procedure and check plumbing tunnels for signs of illicit activity at least once per shift. In addition, plumbing tunnels have been thoroughly cleaned, existing light bulbs have been replaced with brighter bulbs, and additional lighting and motion detectors have been installed.

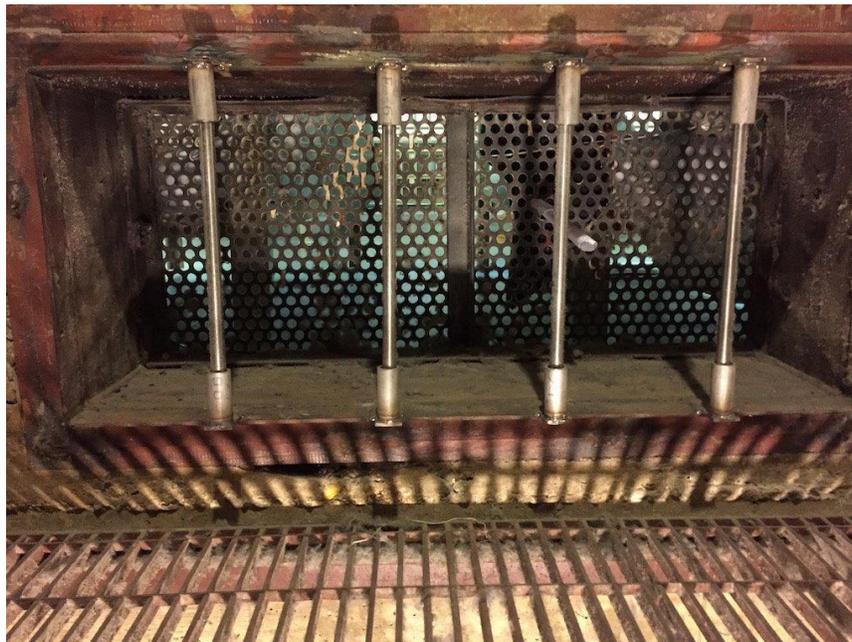
Figure 3

- CCTV in the plumbing tunnels
- Motion sensors
- Radio frequency identification (RFID) tags for all inmates
- Vent bars (see Figure 3)
- Security mesh bars

Vent Bar Reinforcement: After the January 2016 Escape

Additional components of the hardening process, recommended by an OCSJ Jail Hardening Team formed shortly after the jail escape, include the addition of metal grills to plumbing tunnel wall vents; addition of secondary grills to existing security grates; and an upgrade to high density LED lighting on the roof and perimeter of the building (see Figures 1 and 2). Part of the long term hardening desired by the OCSJ is to fence the roof completely. If that proves to be too costly, fencing will be added around air handler/roof vent units, which were used by the inmates to access the roof and escape.
